Machine Service Bulletin No. 429-A

Model: LA LA-5 LA-6

DATE: 7-2-46

SUBJECT: Plus and Minus Keys Action

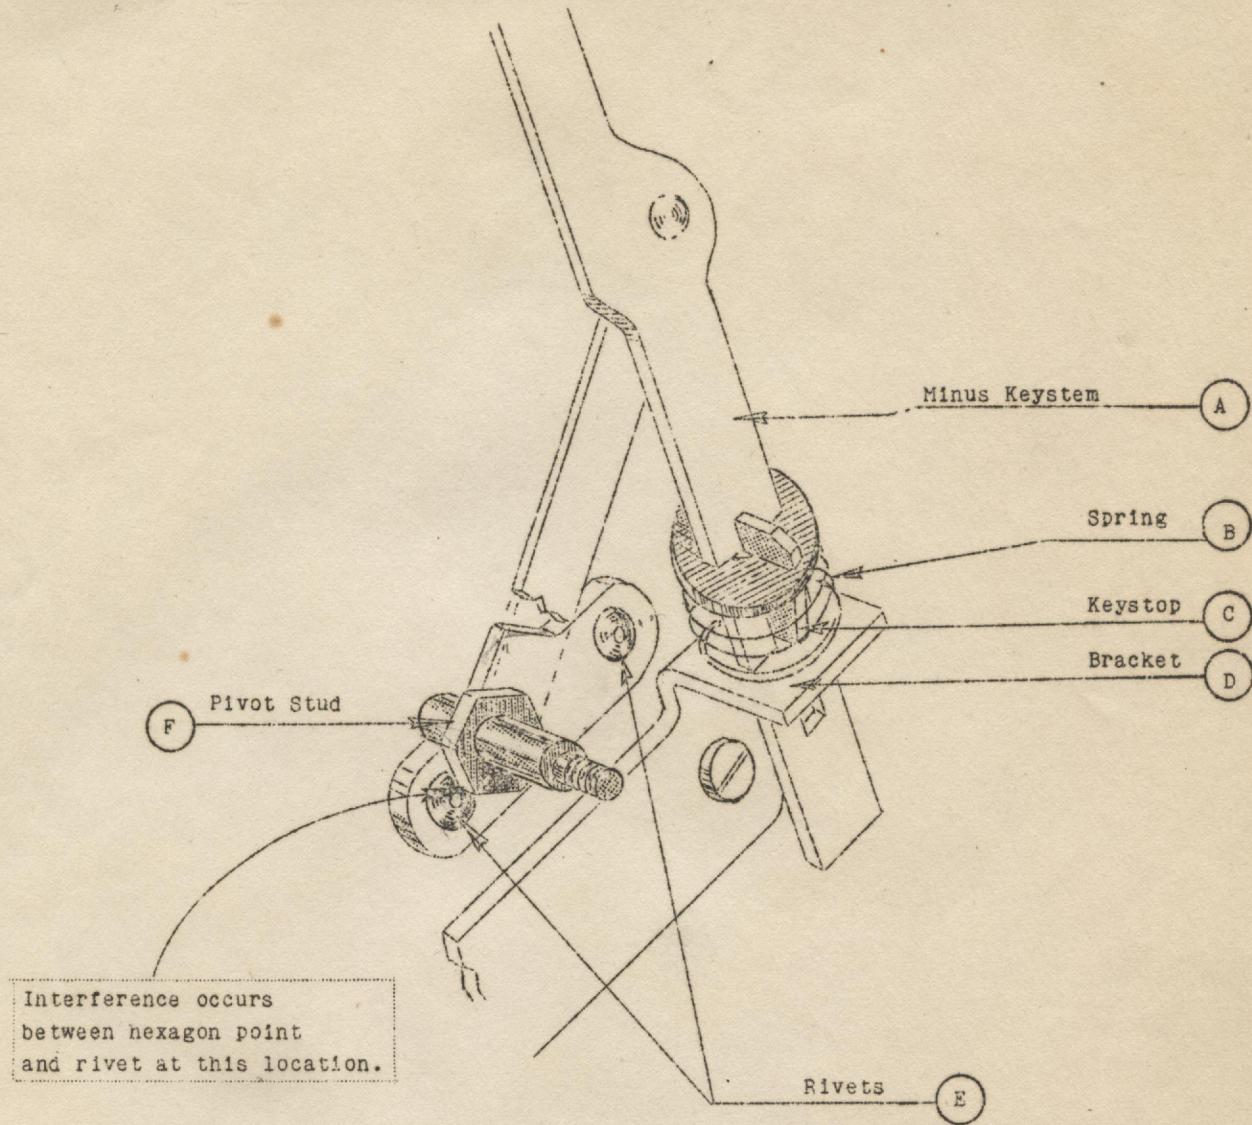
If a point of the hexagon on (F) should engage the head of (E), it is possible that depression of the plus or minus key could occasionally fail to fully move the clutch yoke into engagement with the transmission.

To determine if interference exists between (E) and (F) when either plus or minus key is depressed, lift spring (B) and note if keystop (Liberty Bell) (C) is limiting on bracket (D) as it should.

When installing the mechanism shown in Machine Service Bulletin No. 429, it is recommended that stock be removed from rivets (E) to prevent interference with pivot stud (F).
